**Final Report on the
I-129 Missouri River Bridge
Deck Condition Assessment Using Non-Destructive
Testing Methods**

Bridge No. 9700.0S129, Sioux City, IA

**Final Report
I-129 Missouri River Bridge
Deck Condition Assessment Using Non-Destructive Testing Methods
Bridge No. 9700.0S129, Sioux City, IA**

November 5, 2012

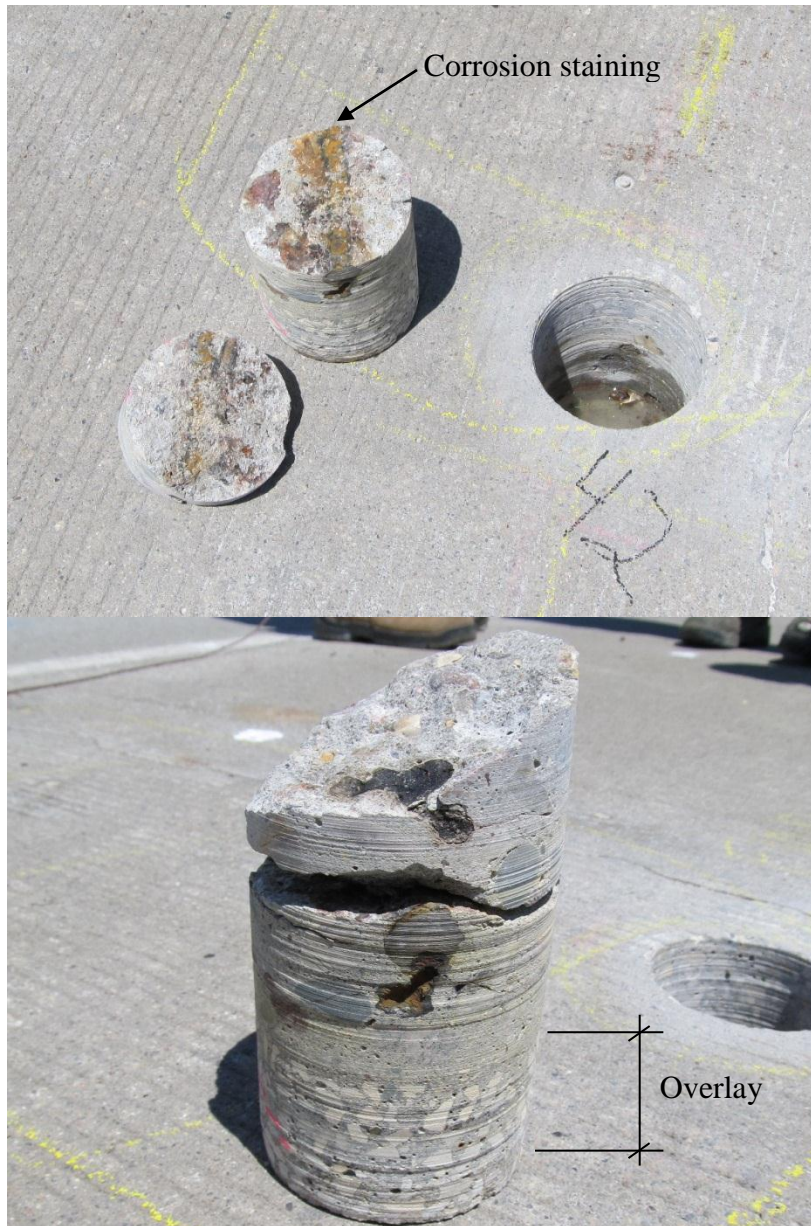
Core sections separated to show both faces of core at delamination plane.

Figure 2.11. Core sample with evidence of horizontal cracking/delamination along the plane of reinforcement due to corrosion of the reinforcing. Note smaller coarse aggregate in overlay visible in bottom photograph.

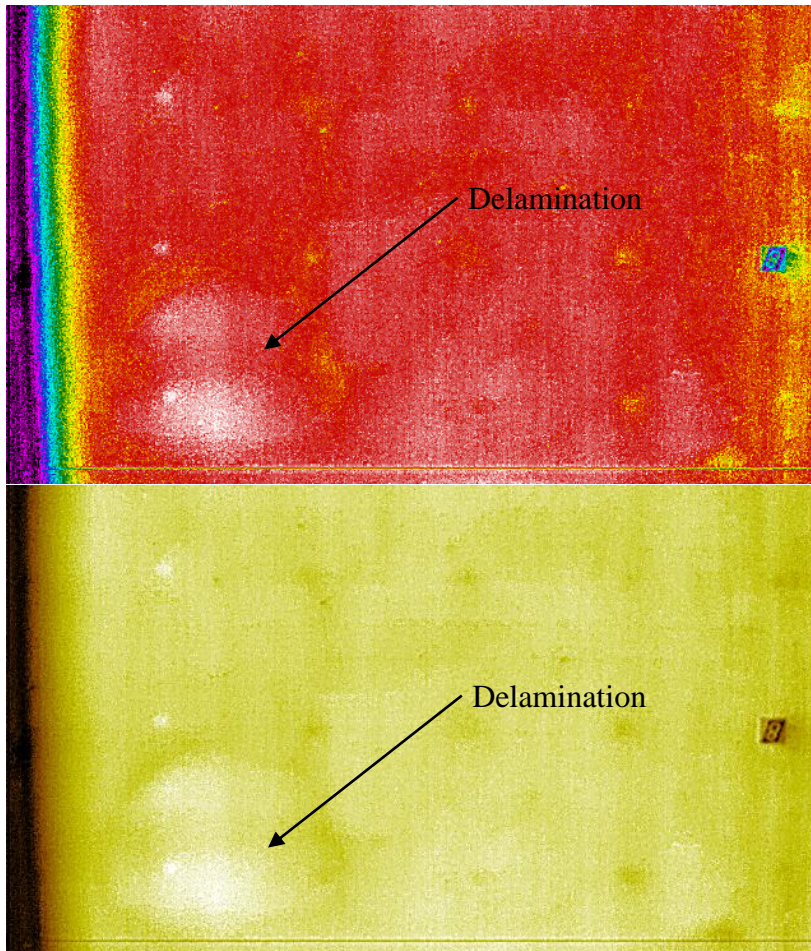
Figure 3.3. Sample infrared image, filtered using the rainbow (top) and sepia (bottom) palettes with upper and lower temperature bounds separated by 18°F (10°C). A delamination is present in the lower left corner of the image (arrow).

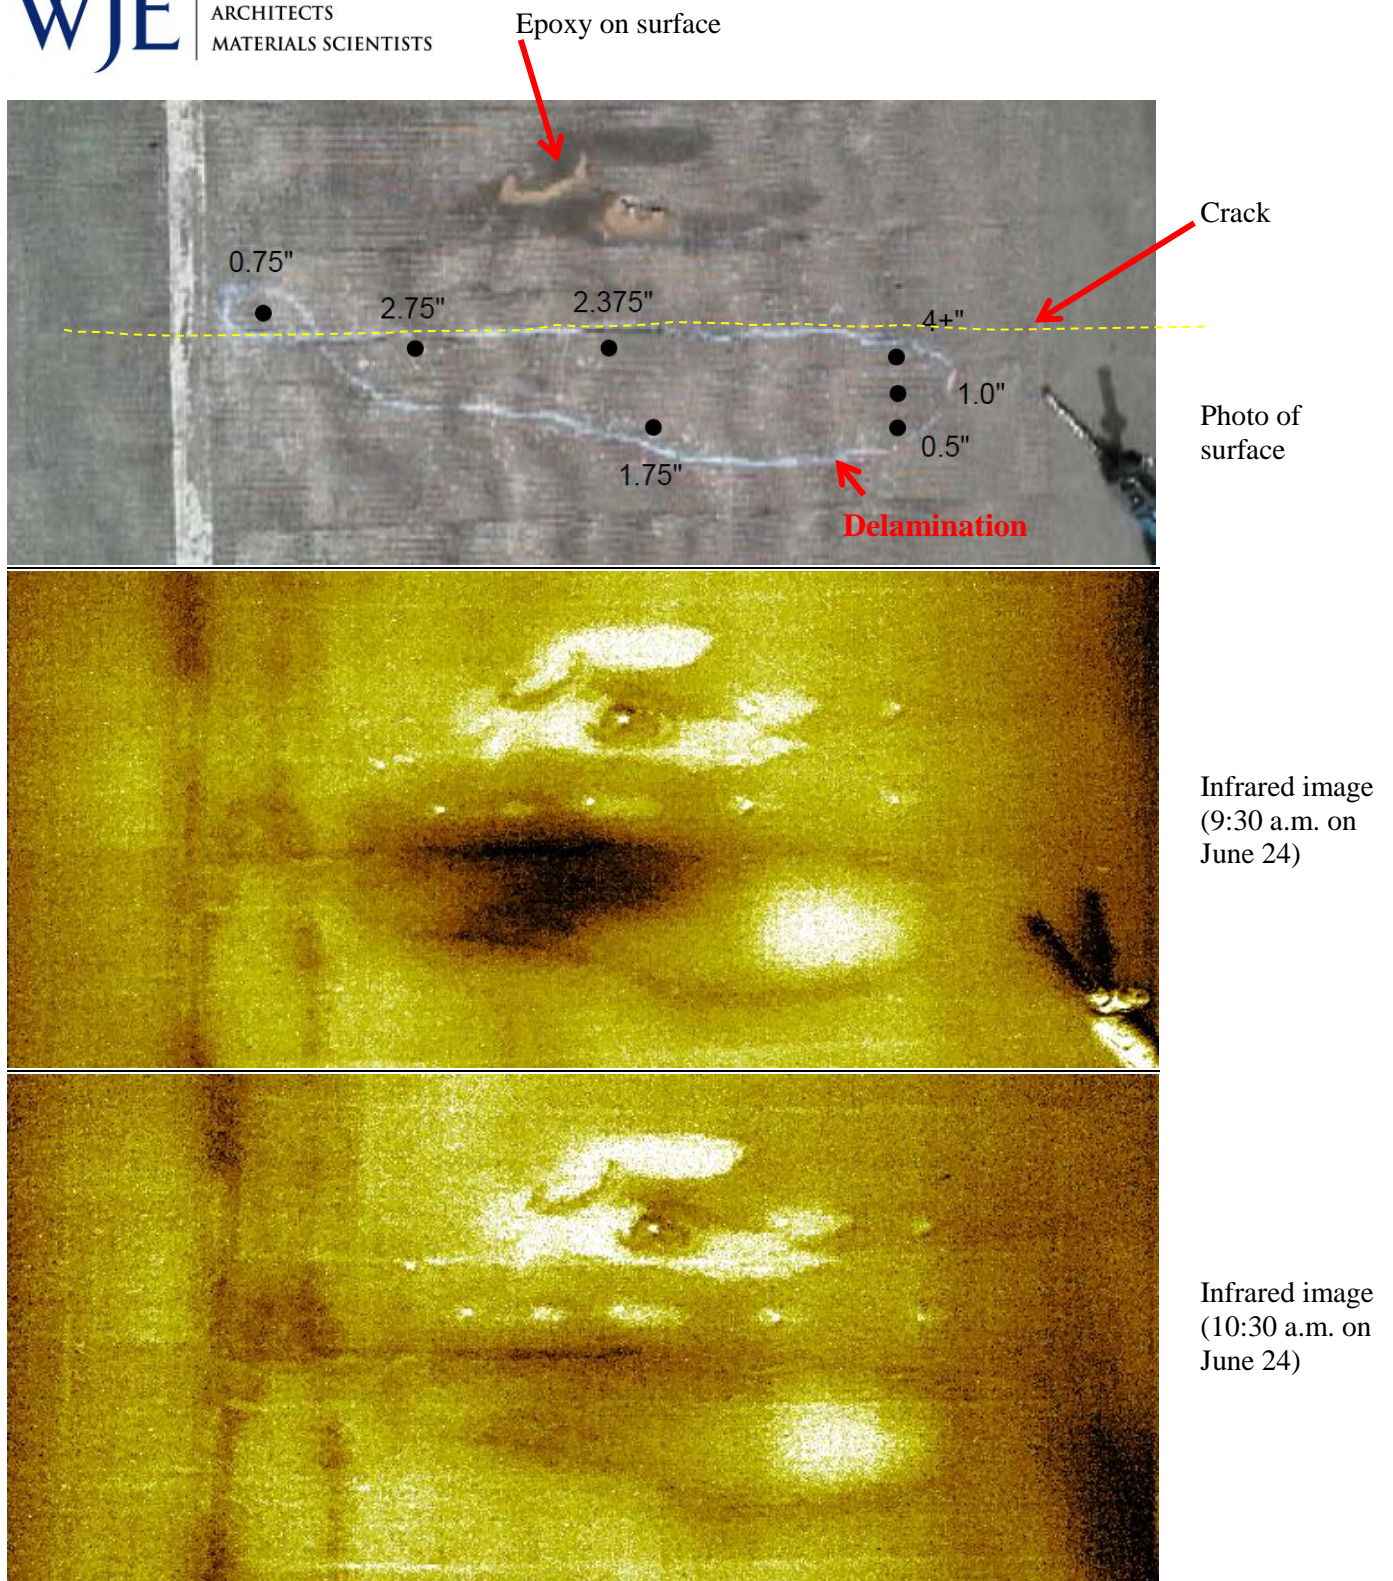
Figure 3.11. Study of depth of delamination in westbound lanes: photo of marked delamination with results from drilling indicating depth of delamination and crack location (highlighted in yellow); infrared image taken at 9:30 am on June 24; infrared image taken at 10:30 am on June 24 (top to bottom).

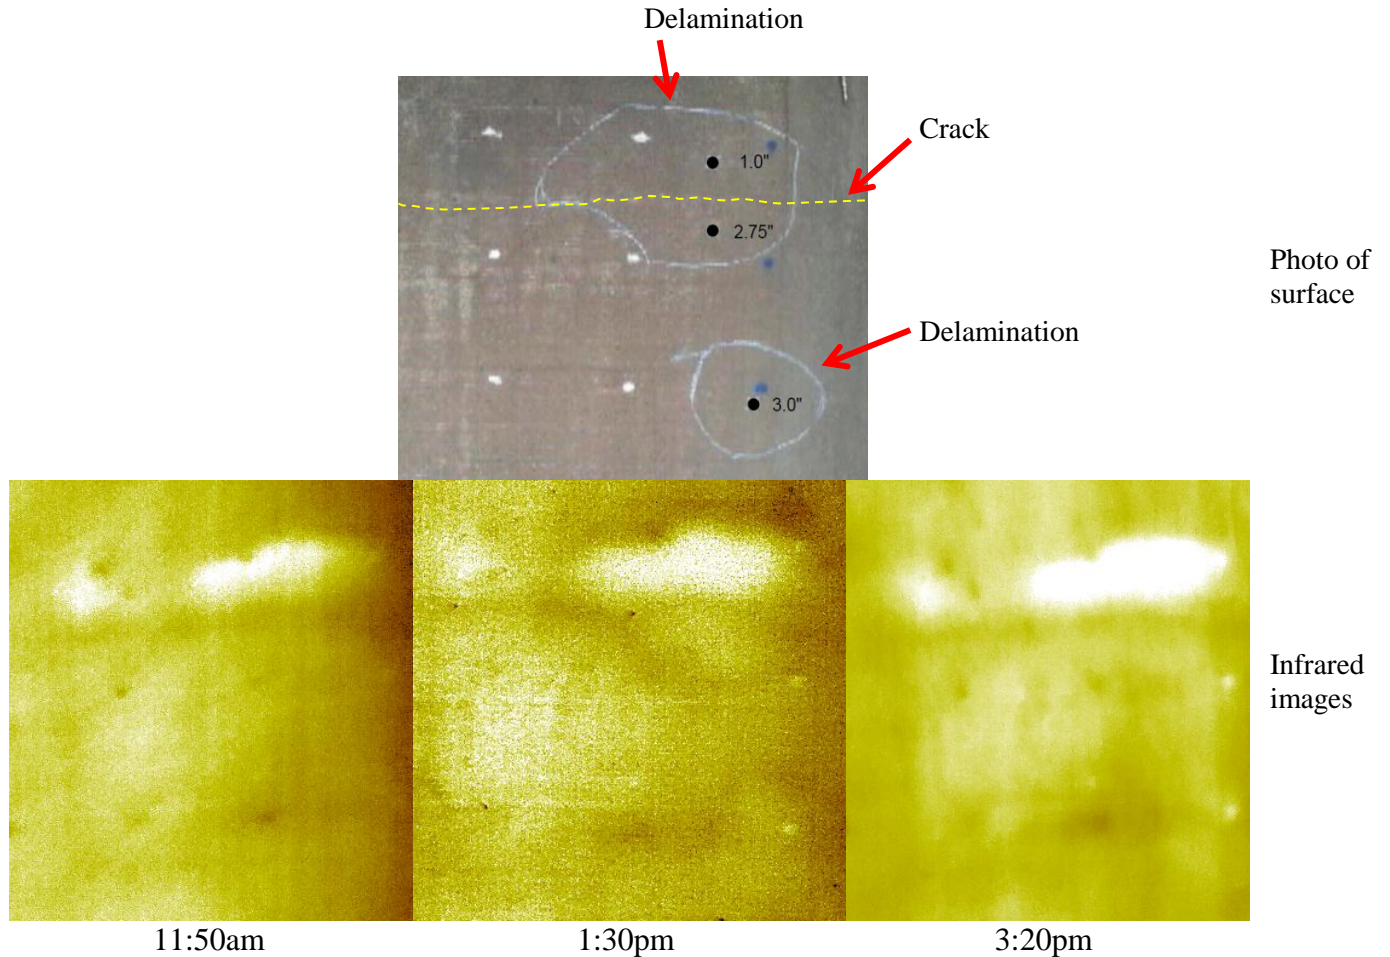
Figure 3.12. Study of depth of delamination in eastbound lanes: photo of marked delamination with results from drilling indicating the depth of the delamination and crack location (highlighted in yellow, top); infrared images taken at the times shown (bottom). The bright spot observed in the top left of the infrared image is not associated with a delamination, but with a dark spot on the deck surface.

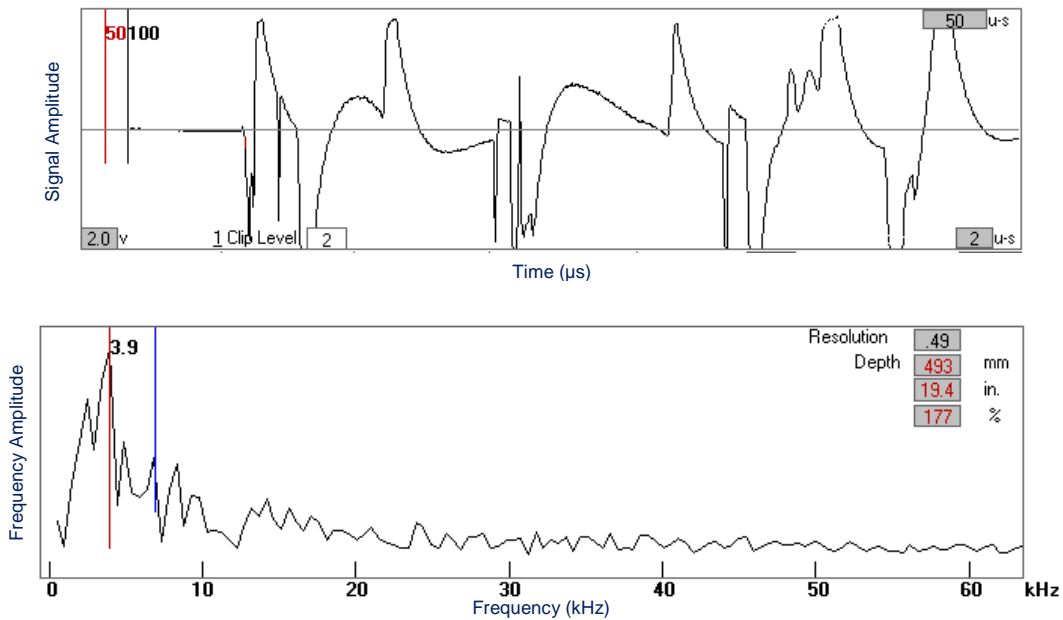
Figure 5.6. IE test result showing a shallow delamination (Study Area EB-1; Station 318).

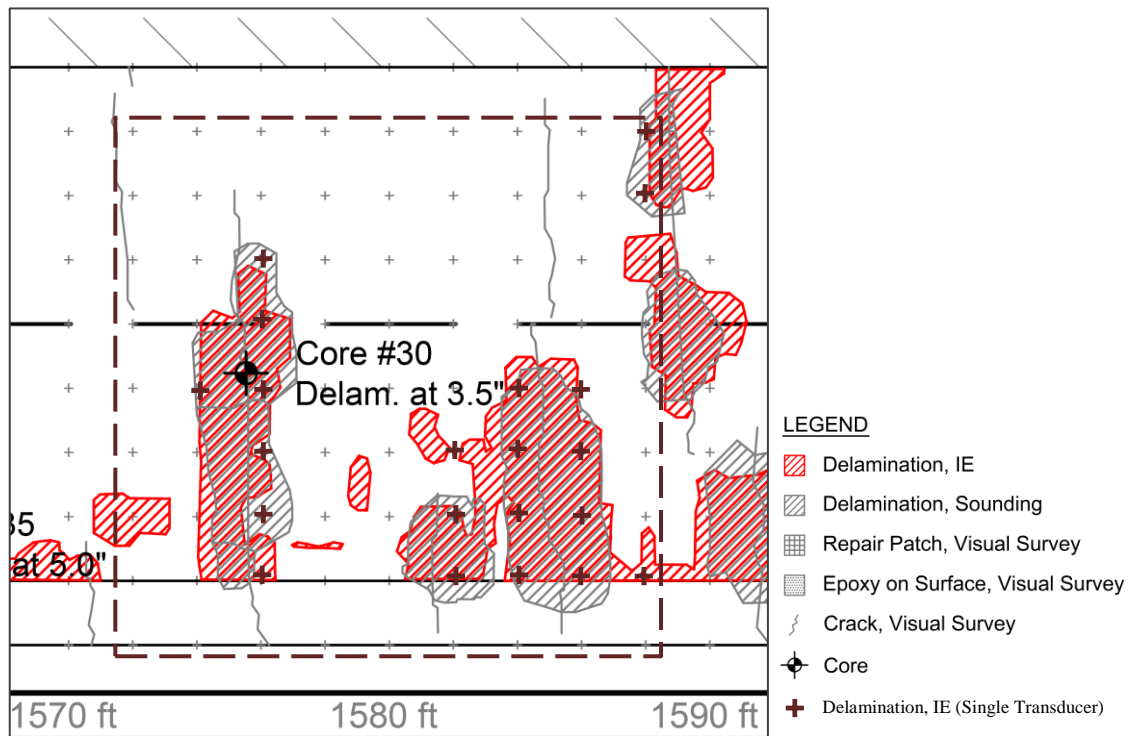
Results of the single-transducer IE testing were overlaid onto portions of the plan view drawings provided in Appendix D. Testing results at Station 1572 to 1588 within Study Area EB-2 are shown in Figure 5.8. In the figure, areas of shallow delaminations identified by scanning IE are hatched red and discrete test points identified as delaminated by the single-transducer IE testing are shown as dark crosses. In each of the three selected test areas, results of the IE testing using the single-transducer unit correlated well with the areas of shallow delaminations identified with scanning IE.

Figure 5.8. Results of single-transducer IE testing (delaminations identified at brown crosses) shown along with results of Scanning IE (hatched red) and sounding at Study Area EB-2 (Station 1572 to 1588).

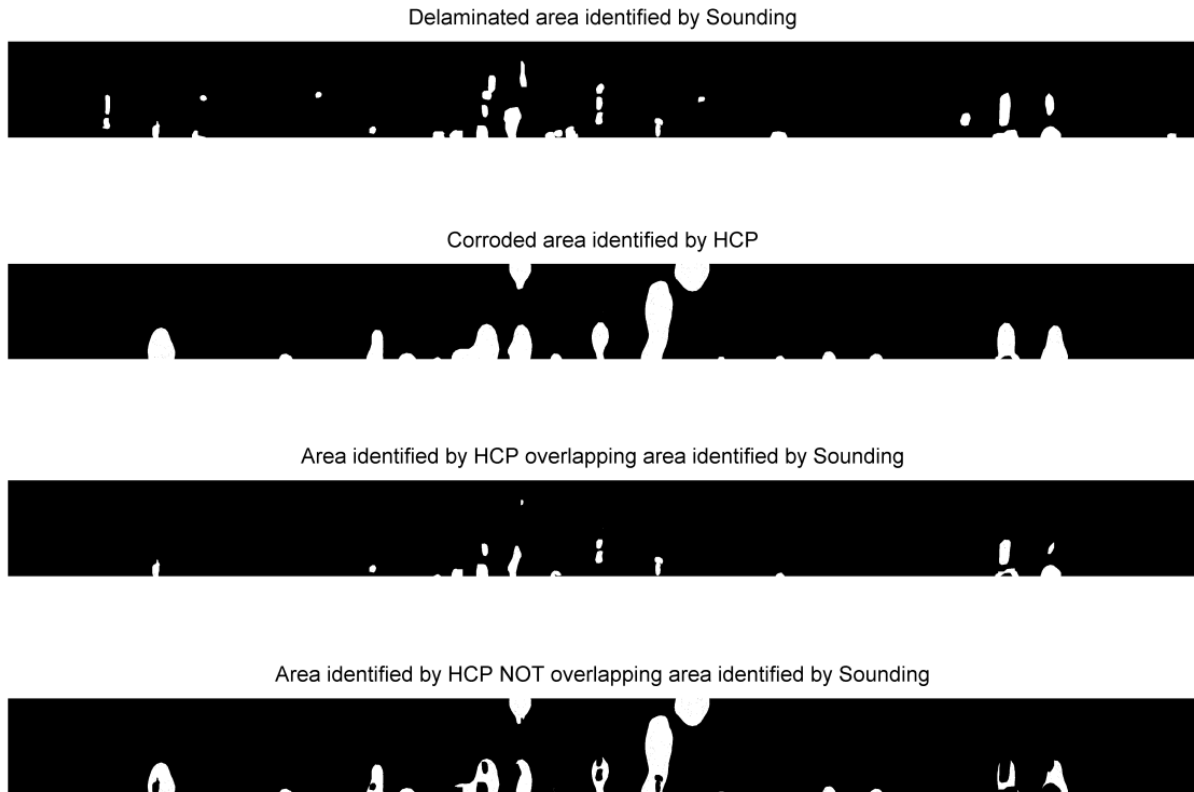
Figure 6.7. Images used to calculate the overlapped and not overlapped area between the delaminated areas identified by sounding and the areas identified by half-cell potential survey threshold of -250 mV vs CSE (example from Study Area EB-1).

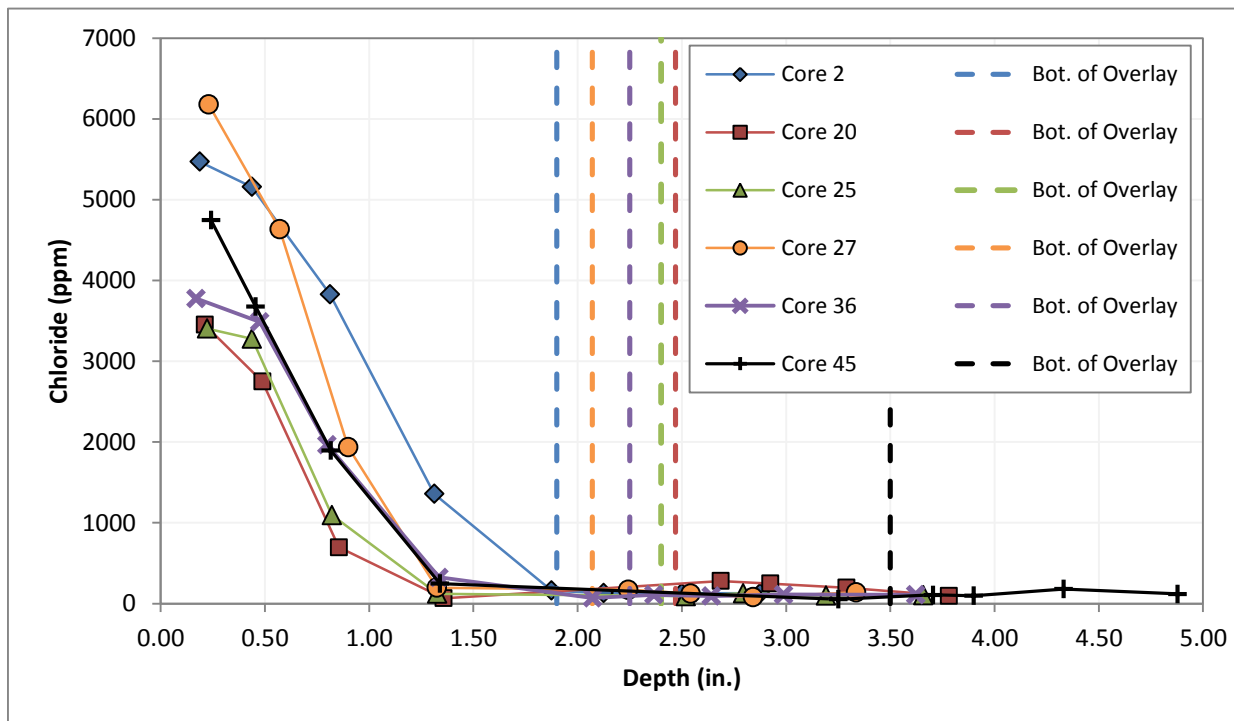
Figure 8.3. Cores from sound concrete (uncracked and no delaminations). Measured chloride contents and overlay thickness, measured as distance from the top surface of the overlay.

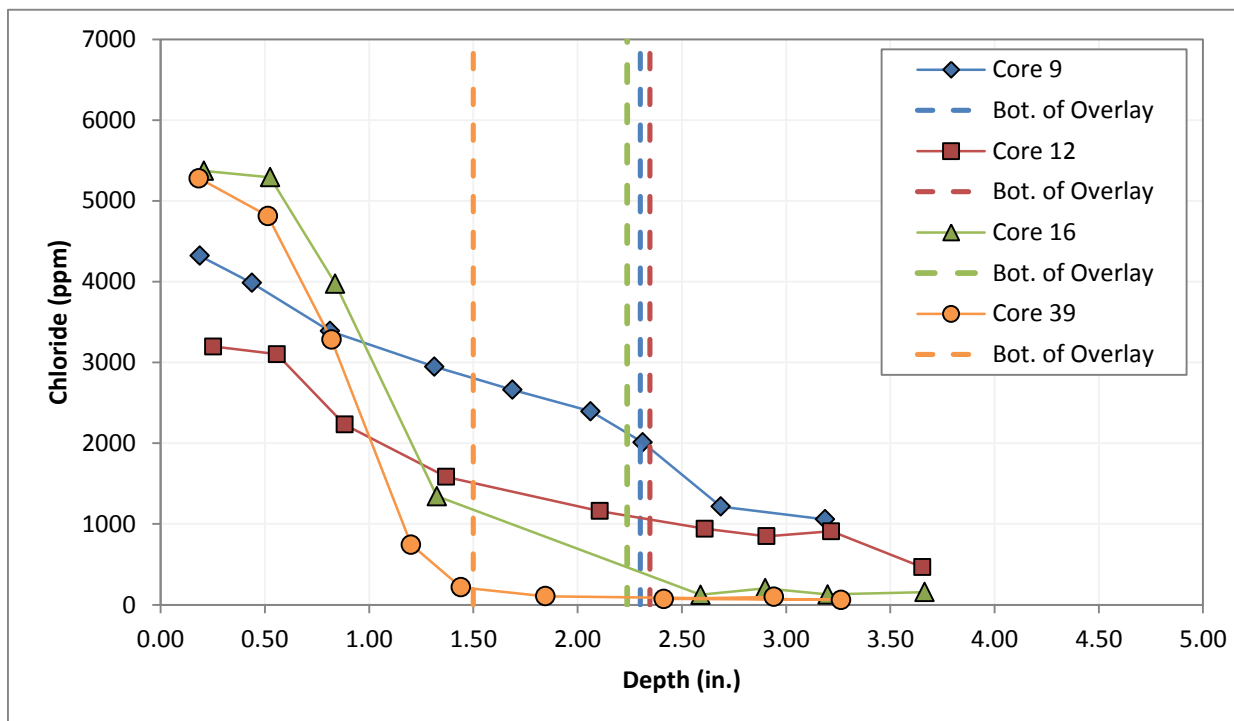
Figure 8.4. Cores with delaminations. Measured chloride contents and overlay thickness, measured as distance from the top surface of the overlay.

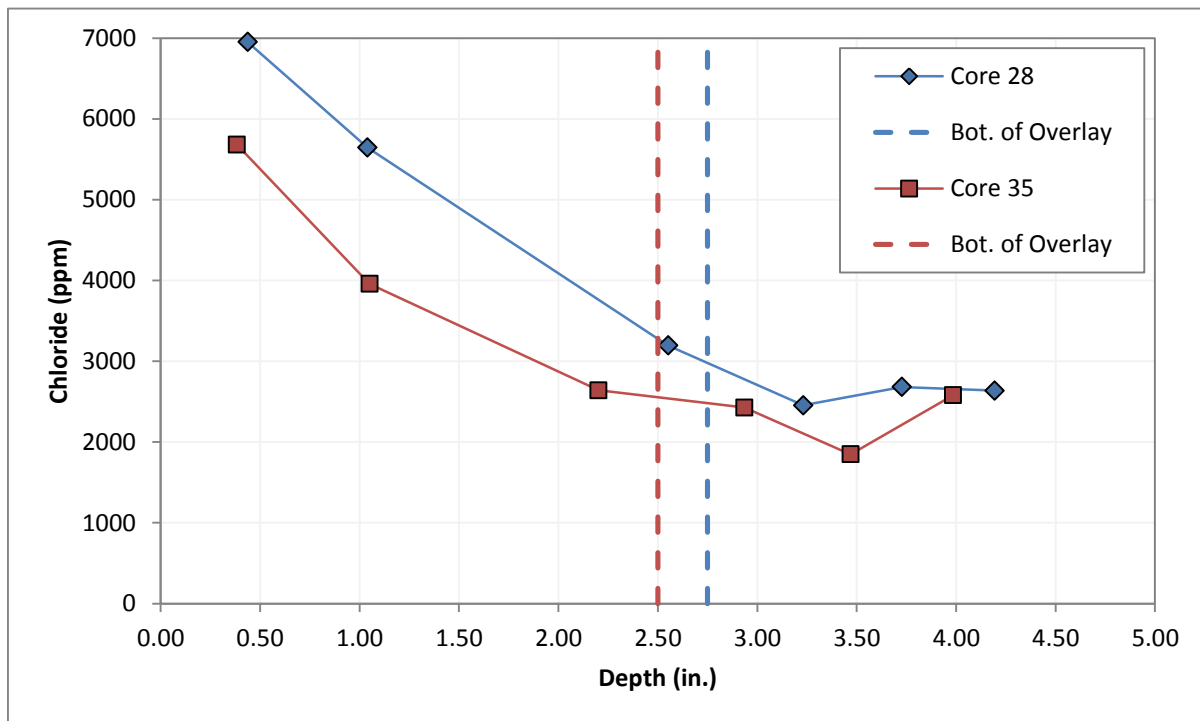
Figure 8.5. Cores with through-thickness vertical cracks. Measured chloride contents and overlay thickness, measured as distance from the top surface of the overlay.

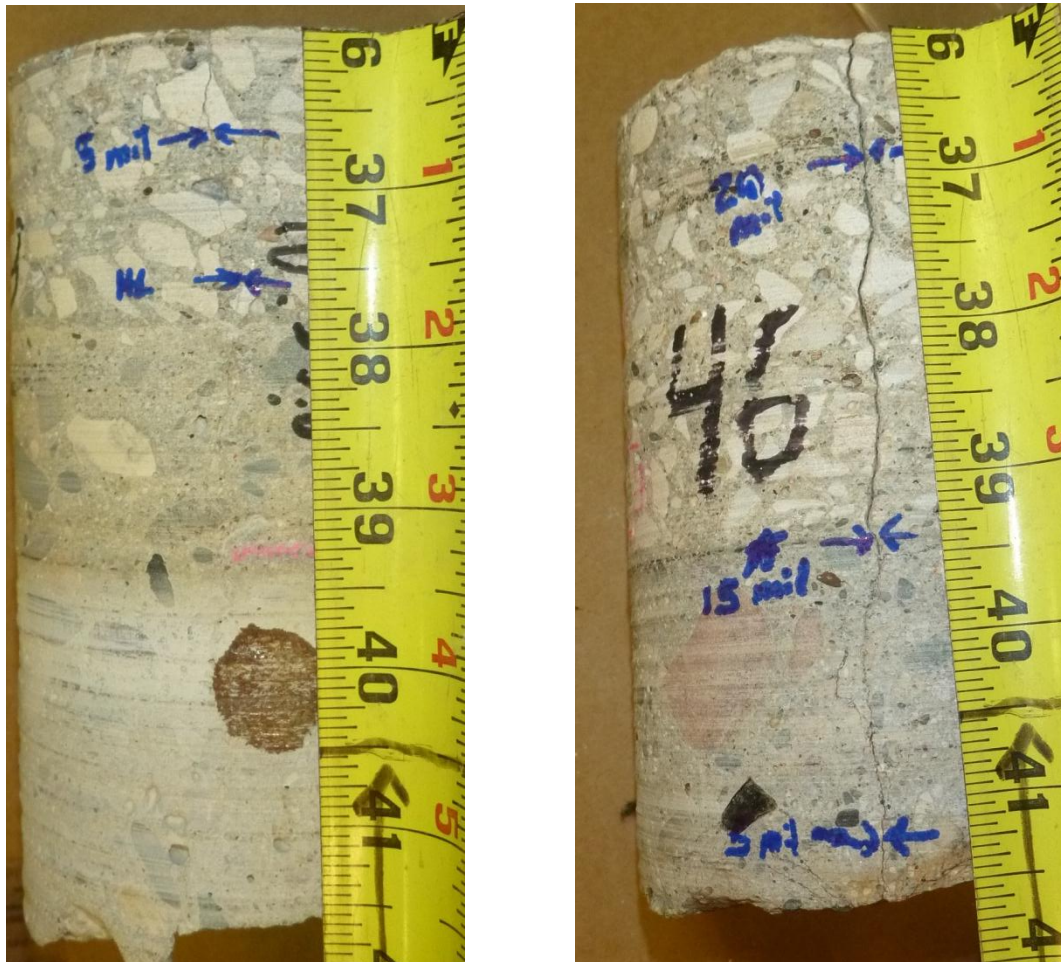
Crack widths ranged from 10 to 30 mils; further examination of extracted cores indicated that the cracks narrowed to 1/3 or less of the surface width as they approached the bar depth (Figure 8.7). For the purposes of modeling and based on the findings of the field investigation, crack width was estimated to be log-normally distributed, with a median value of 5 mils and a coefficient of variation of 60 percent.

Figure 8.7. Comparison of crack width versus depth for Cores 33 and 46.

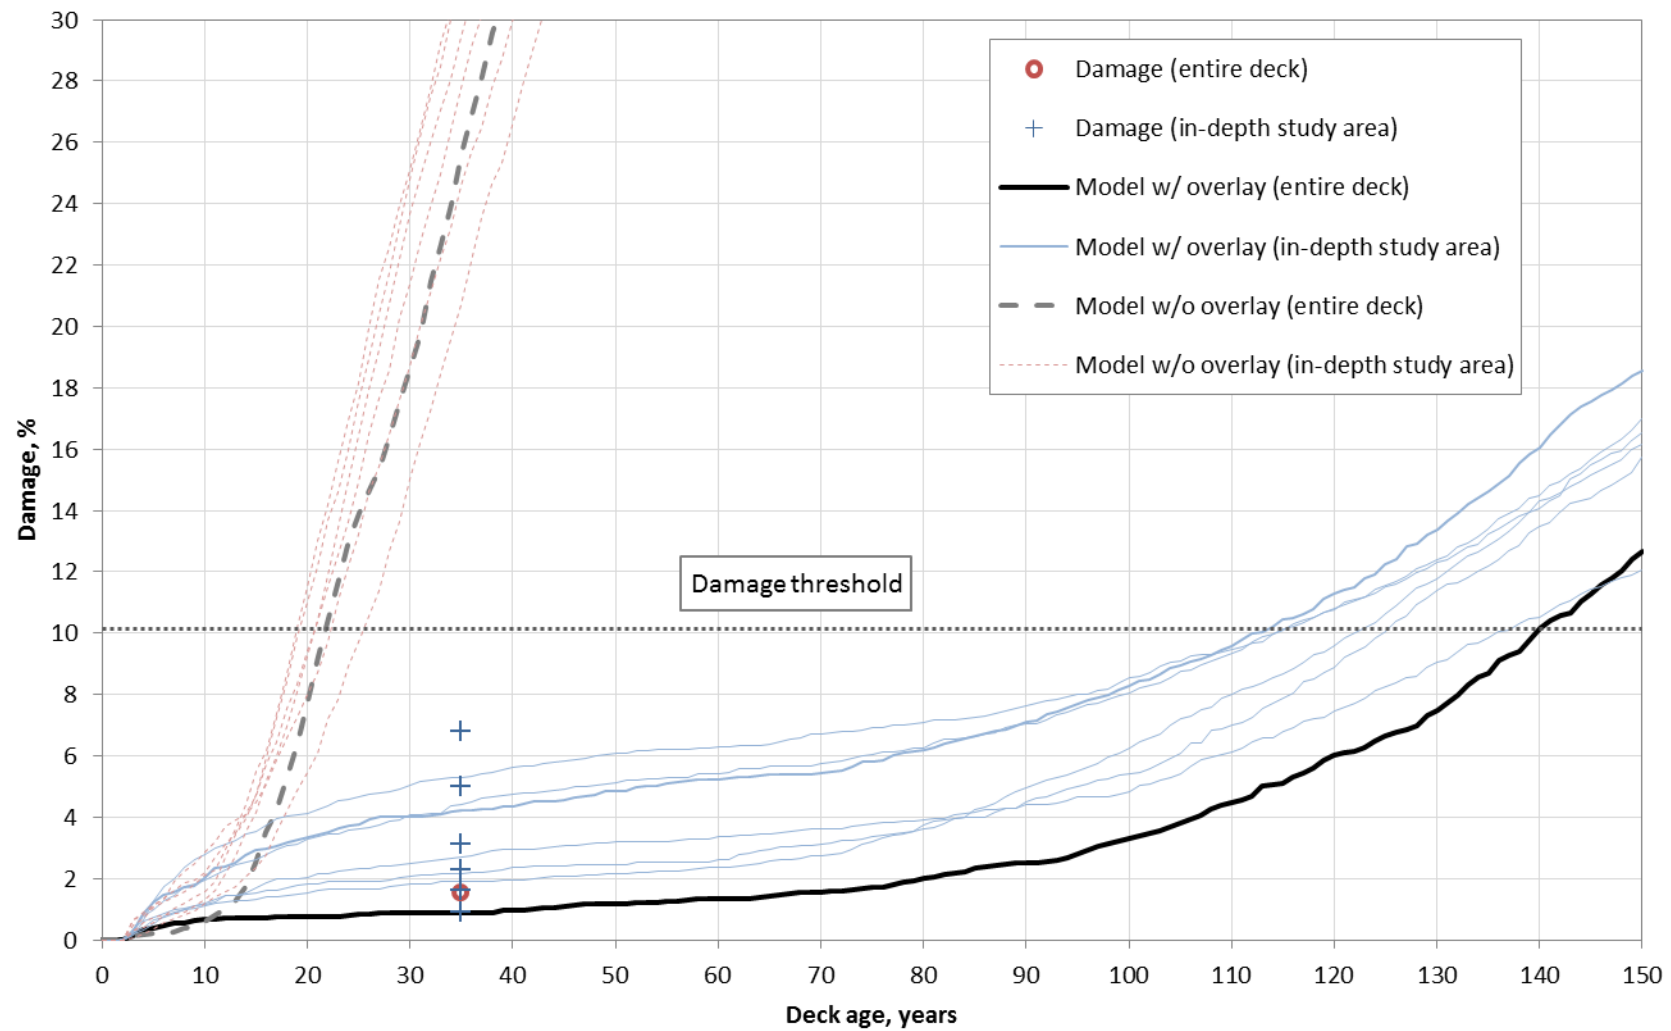
8.3.2.1 Projected Service Life. The service life model results, in terms of predicted damage (area of deck exhibiting corrosion-related delamination or spalling) versus time, for the entire deck on average and for each of the in-depth study areas are plotted in Figure 8.10. In the figure, solid lines indicate the predicted damage versus time for the I-129 bridge as constructed, which includes the beneficial effects of the low-permeability overlay. Also shown on this figure as single points are the actual damage areas observed to date for the entire deck and for each of the in-depth study areas.

Figure 8.10. Service life model results: Plot of damage versus deck age for both the in-depth study areas and the entire deck.

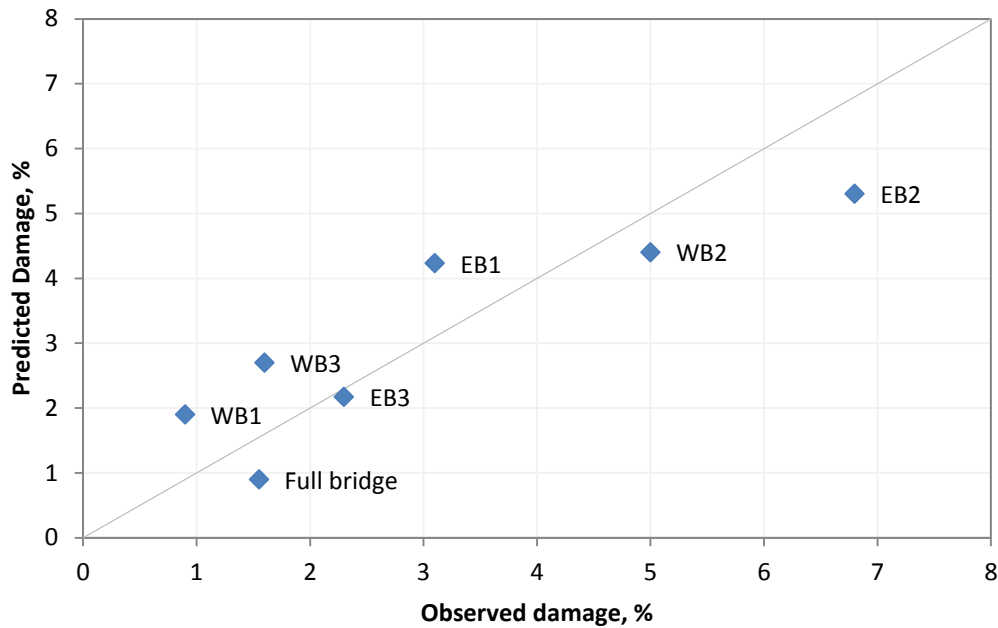
The actual predicted damage versus observed damage through 35 years is plotted for the entire deck and in-depth study areas in Figure 8.11. A diagonal line is provided for reference on the plot, which would indicate a perfect match between predicted and observed values. The plot shows that, although predicted values vary somewhat from observed values, the model predicts observed damage quite well.

Figure 8.11. Plot of predicted damage versus observed damage at 35 years. Data includes both in-depth study areas and entire deck. Line represents perfect agreement between prediction and observed conditions.

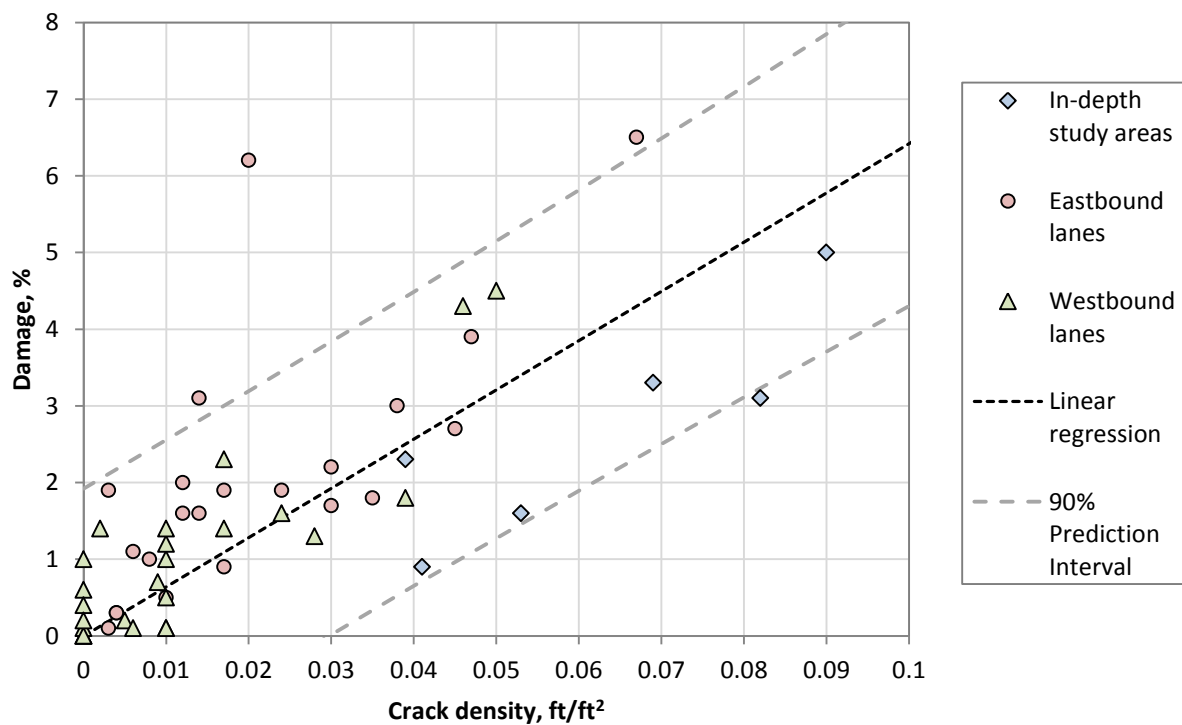
Considering that the bridge as-surveyed is in the second phase of the damage curve, the currently observed damage should strongly correlate with the observed crack density, since that controls the extent of damage in the first phase of the damage curve. Figure 8.12 illustrates this linear relationship between crack density and currently observed damage.

Figure 8.12. Relationship between crack density and observed damage.

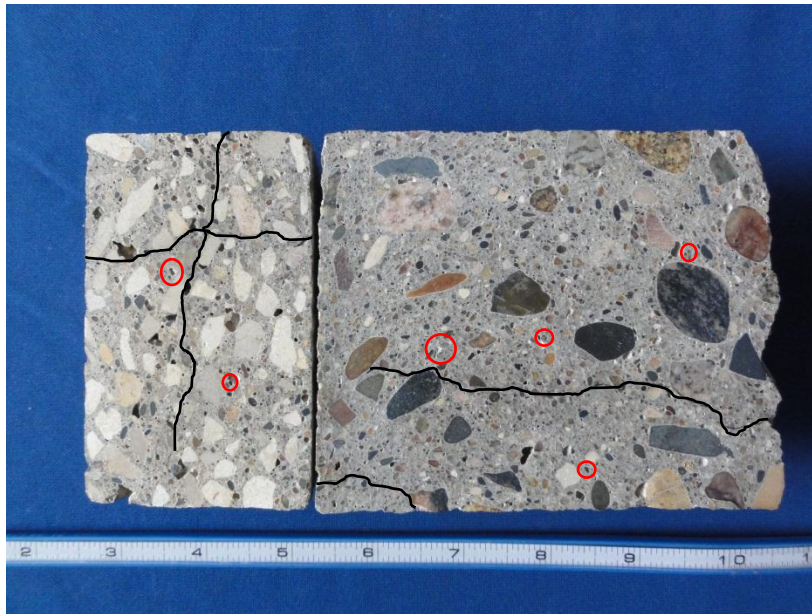
Figure 1. Core 6 and 42 as received for petrographic studies. Topping layer in Core 6 as received was delaminated from the base concrete.

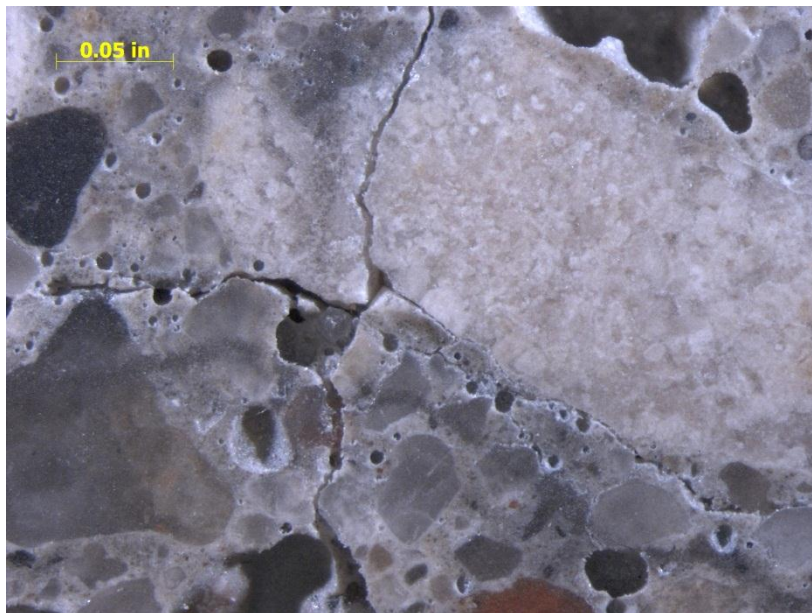
Cracks were detected in both the topping and the substrate concretes. The topping layer had two microcracks; one horizontal, located mid-depth of the layer, and the other vertical. Secondary deposits of salt were present within the pores of the cement paste in localized areas of the top 1 inch of the overlay concrete. (Figures 2, 3, and 4). Because the core was taken adjacent to a delamination, it is possible the horizontal crack is an extension of the delamination plane that has not yet penetrated to the surface.

Figure 2. Lapped section of Core 6; top of the core is on the left of the photo. The locations of the microcracks are outlined. The largest reactive shale particles are encircled.

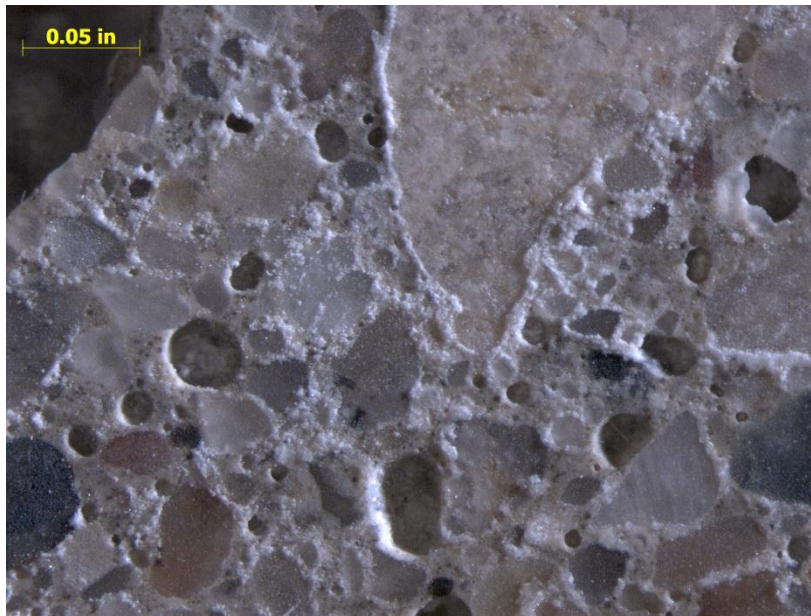
Figure 3. Core 6 topping; close up view of the area where the vertical and horizontal microcracks intercept.

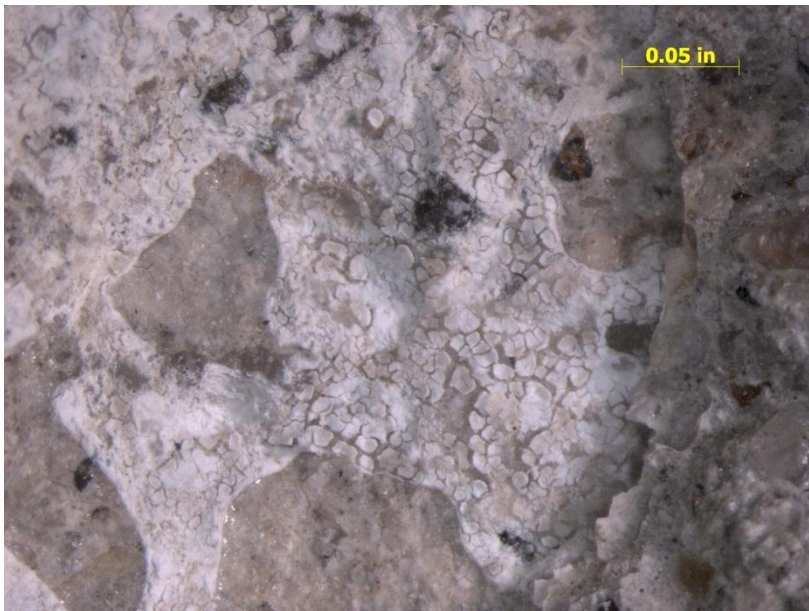
Aggregates - The coarse aggregates in the base concrete were similar to Core 6. However, the coarse aggregates also contained reactive particles not detected in Core 6. The source of most of the ASR gel in cracks appeared to be a large, dark lump that was embedded at the fractured bottom end of the core. The lump appeared to be an industrial waste product and was composed mainly of siliceous glassy material, similar to silica fume. The approximate dimensions of the lump were 1 inch by 3/4 inch. The lump was most likely a contaminant within the aggregate (Figures 10 and 11).

Figure 11. Core 42; close up of the light color area of the bottom surface of the core from Figure 8 showing that the surface is coated with ASR gel.
